Appendix A:
Building Resilient Infrastructure in Communities
(BRIC) Scoping Study

FEMA Building Resilient Infrastructure and Communities (BRIC) Scoping Study for the City of Dyersville

City of Dyersville, Iowa

November 22, 2024

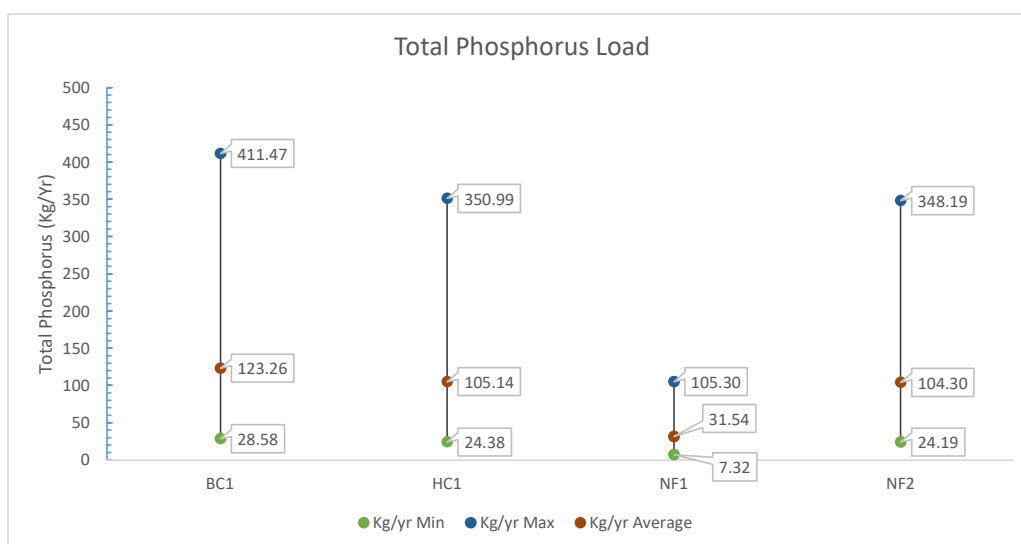
Figure 4: Estimated Total P Contribution from Assessed Eroding Streambanks

Generally, the assessed streams show signs of channel incision and bed degradation. In many areas, the channel banks are as high as ten feet from the streambed. Assuming a bankfull depth of 3 to 4 feet, this indicates the channel bed is now 6 to 7 feet lower than historic conditions. As the channel tries to reach a dynamic equilibrium, this incision causes bank erosion and a subsequent oversupply of sediment farther downstream. Streambank erosion is a major contributor to nutrients, particularly phosphorus (P). Excess P can speed up the process of eutrophication, leading to dangerous algal blooms and fish kills. Sediment contributions were estimated using the BANCS model, which uses the BEHI, NBS, bank height, and length of eroding bank to estimate erosion in tons per year. Approximately 47% of the assessed reach lengths exhibited a streambank with a BEHI of moderate, high, very high, or extreme. These eroding streambanks contribute an estimated total of 854 tons of sediment per year into the stream system. See Table 6 for a summary of the BANCS analysis and **Appendix B** for the RiverMorph BEHI Summary Report. A range of estimates of the total P load associated with the eroding sediments was calculated for each assessed reach based on research from *Total Phosphorus Loads in Iowa Rivers and Estimation of Stream Bank Phosphorus Contribution*.³ See Figure 4 below for the graph of the range of values per reach.

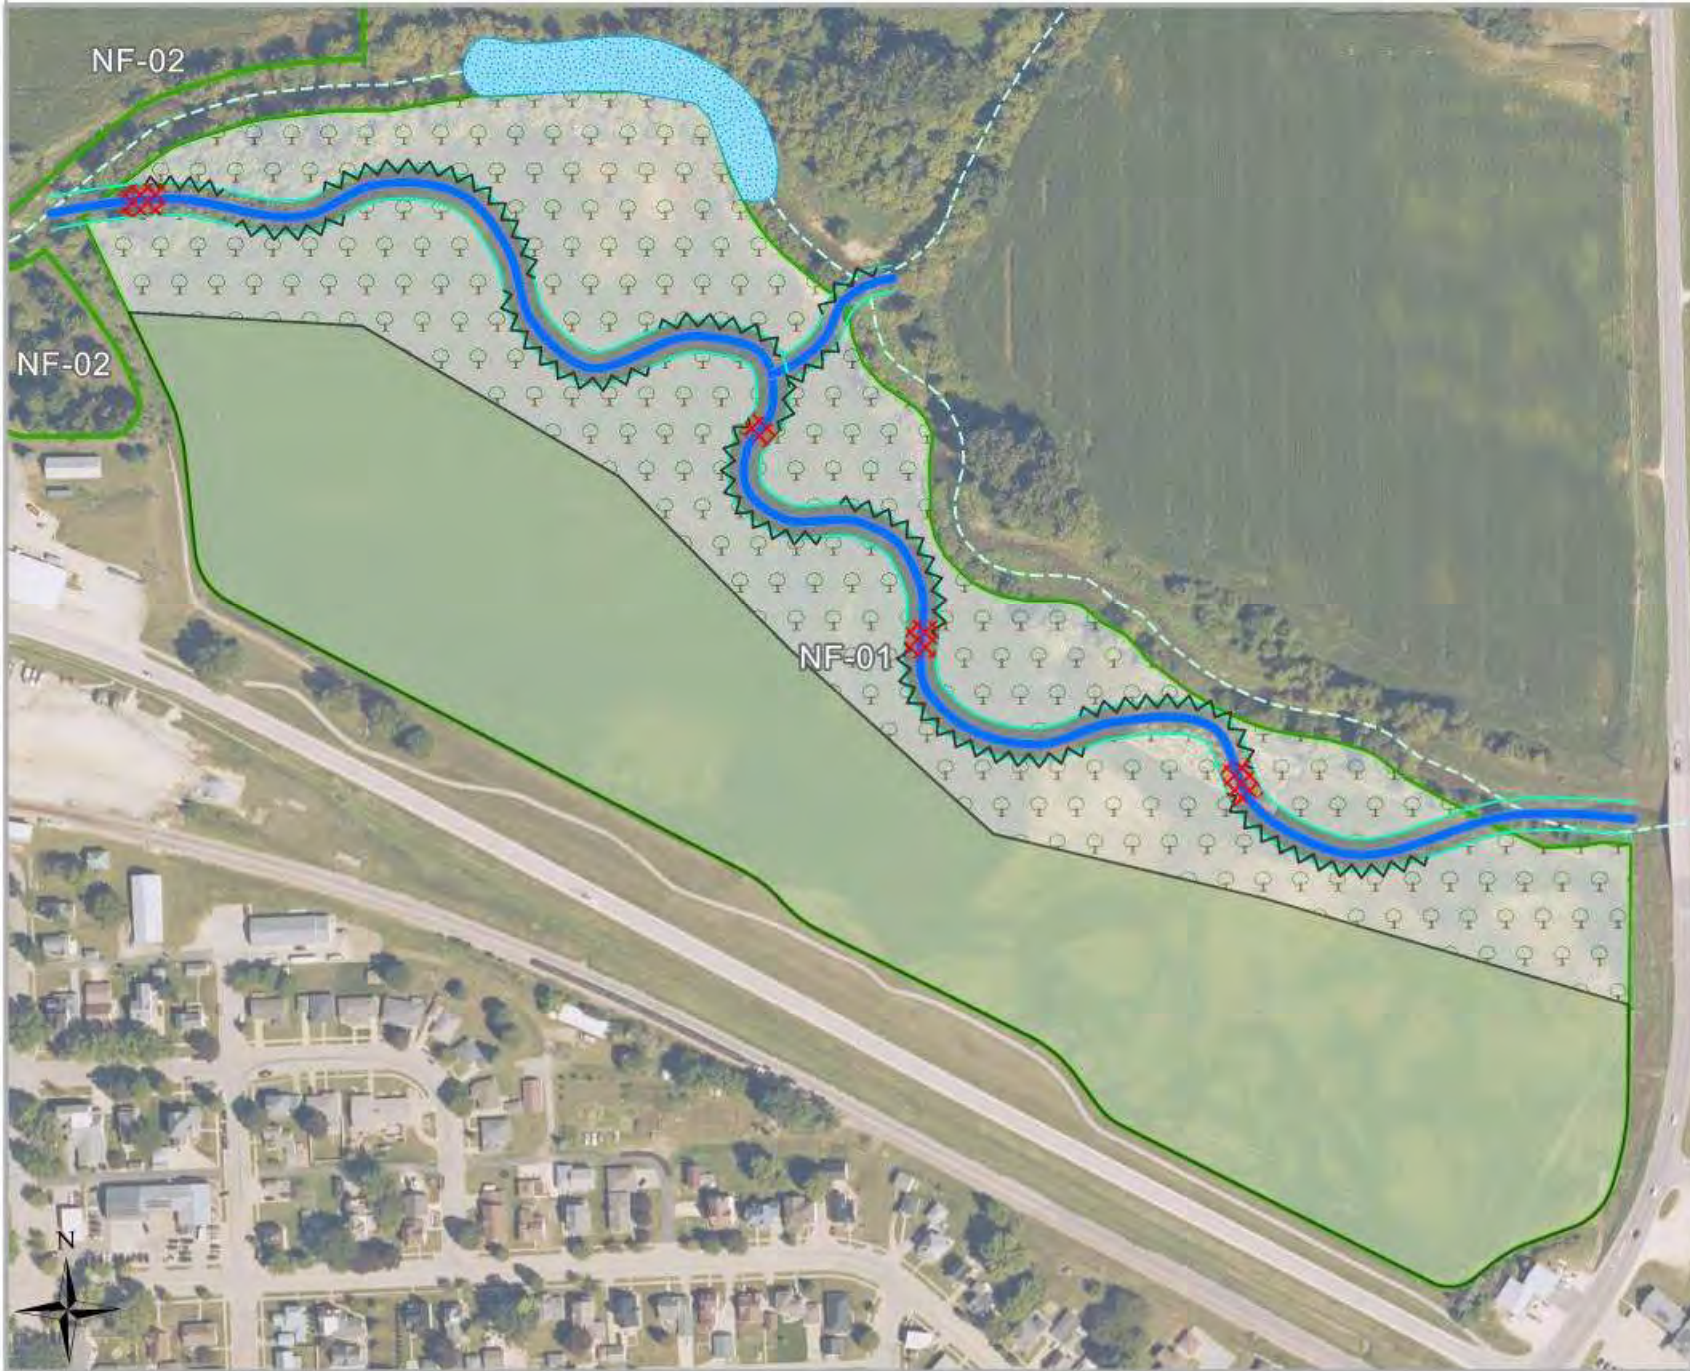
Figure 7
Proposed Practice NF-01

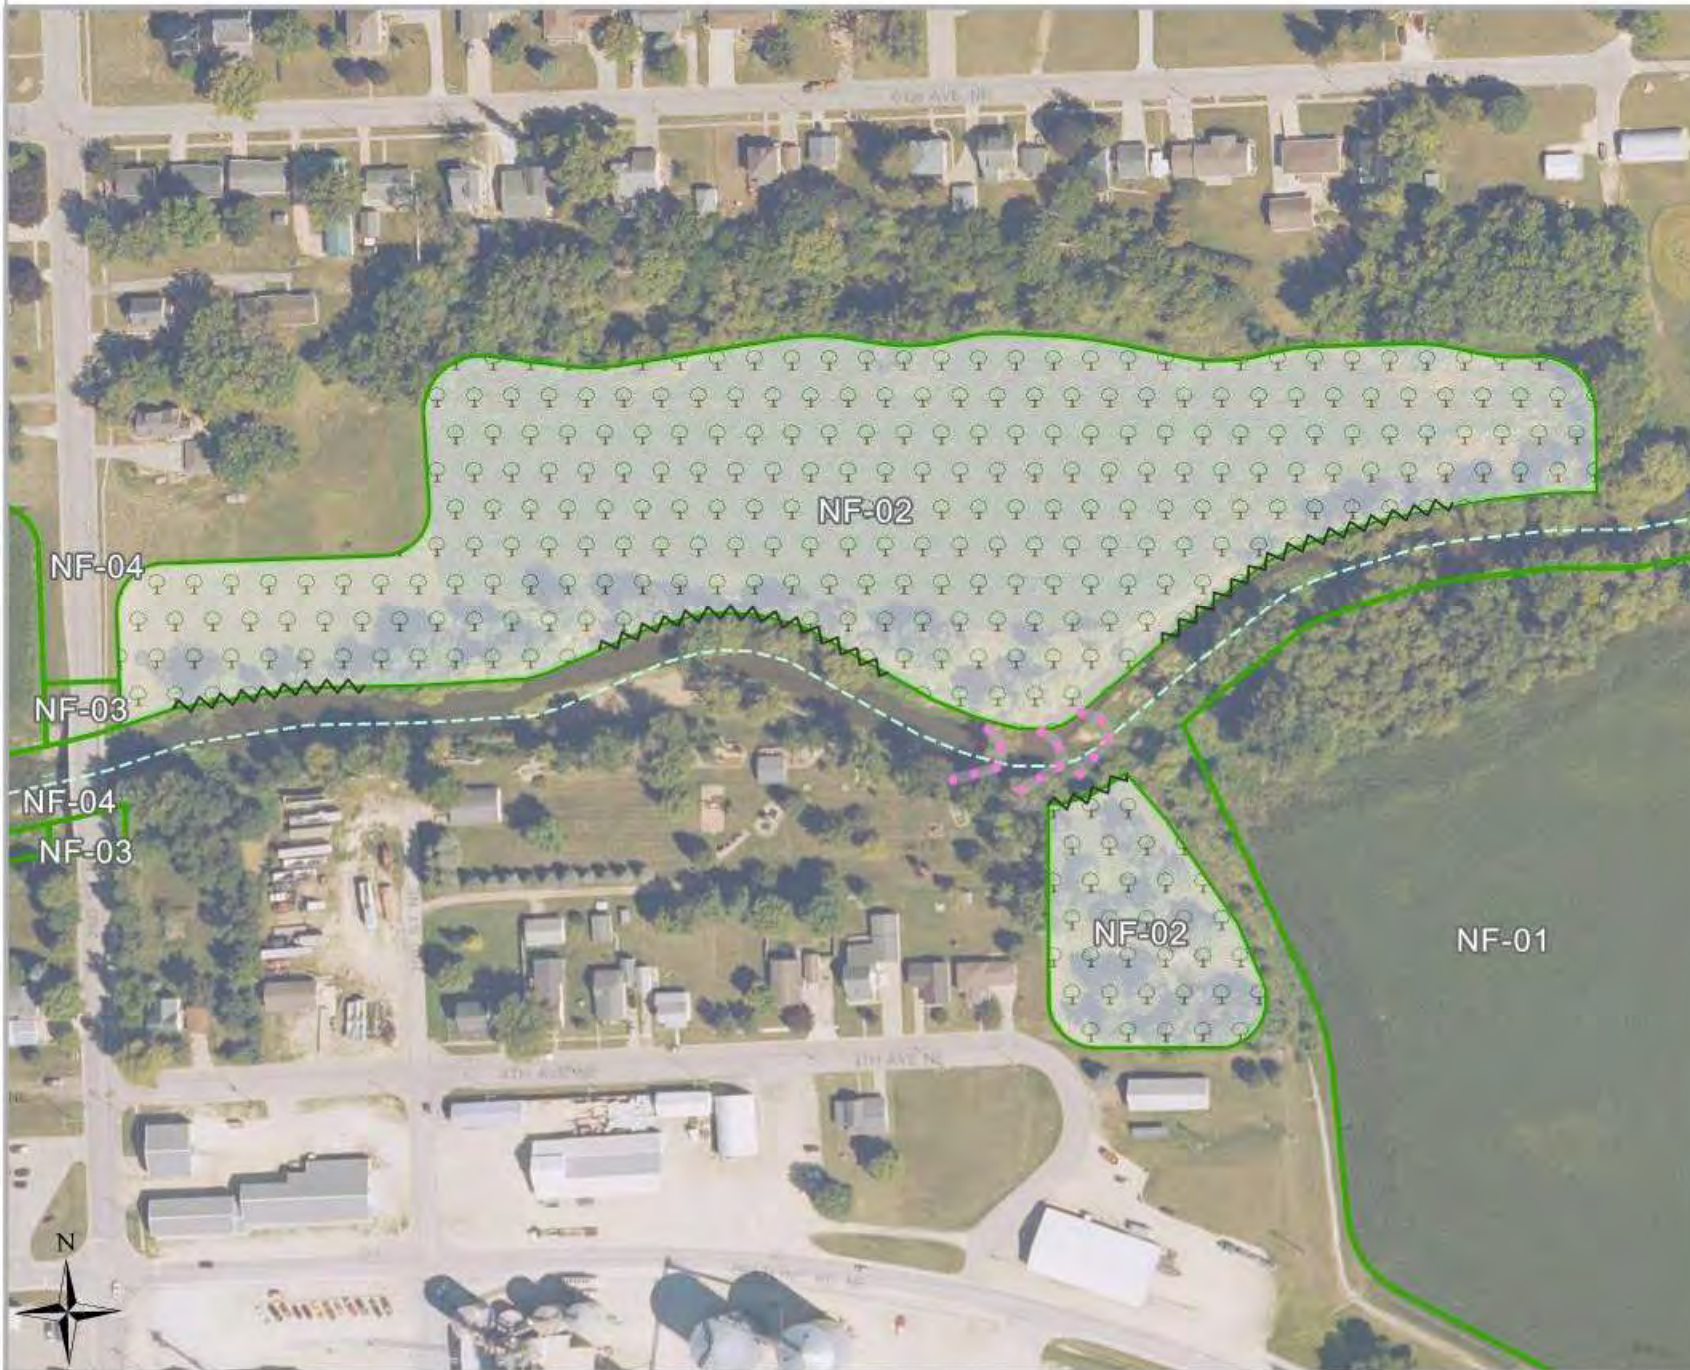
Figure 8
Proposed Practice NF-02

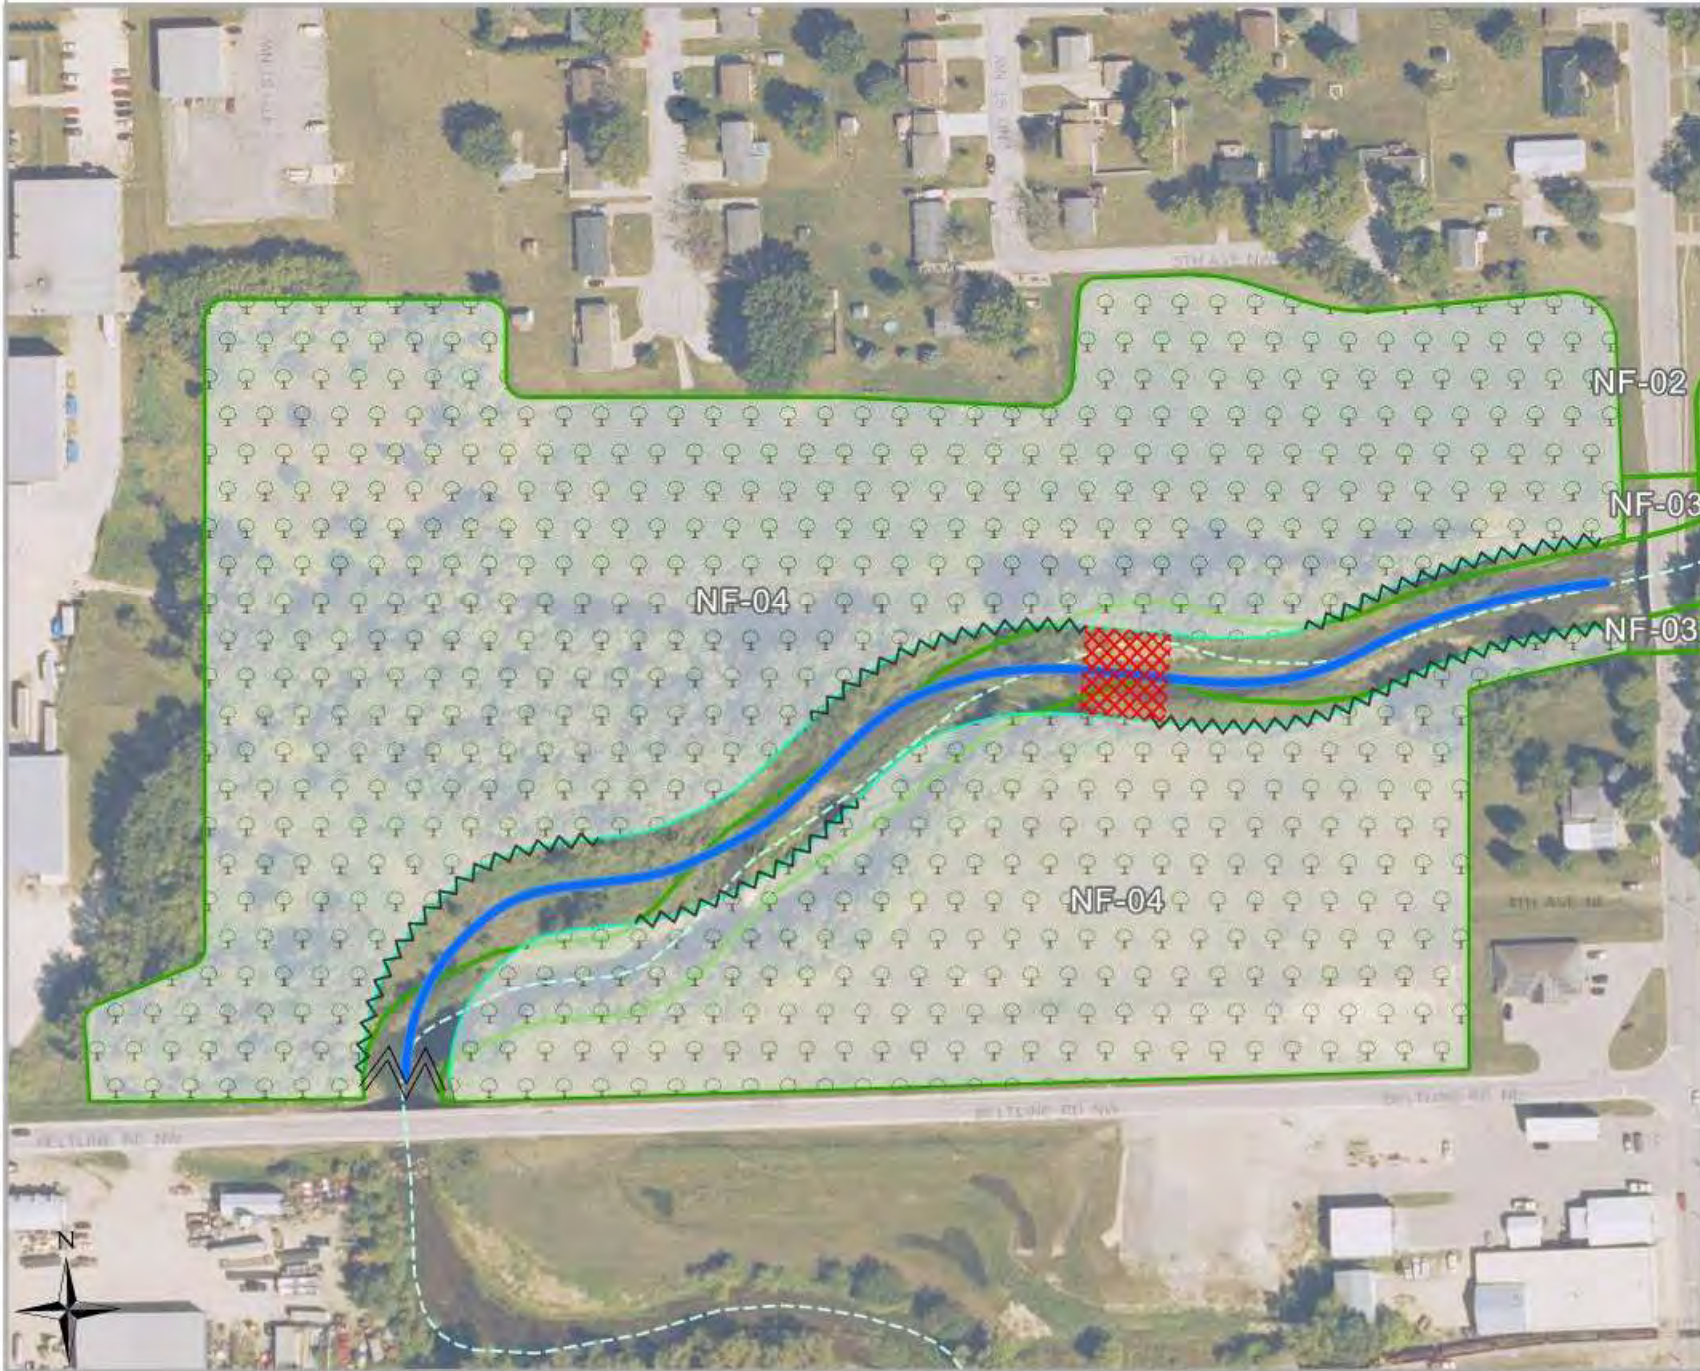
Figure 10
Proposed Practice NF-04

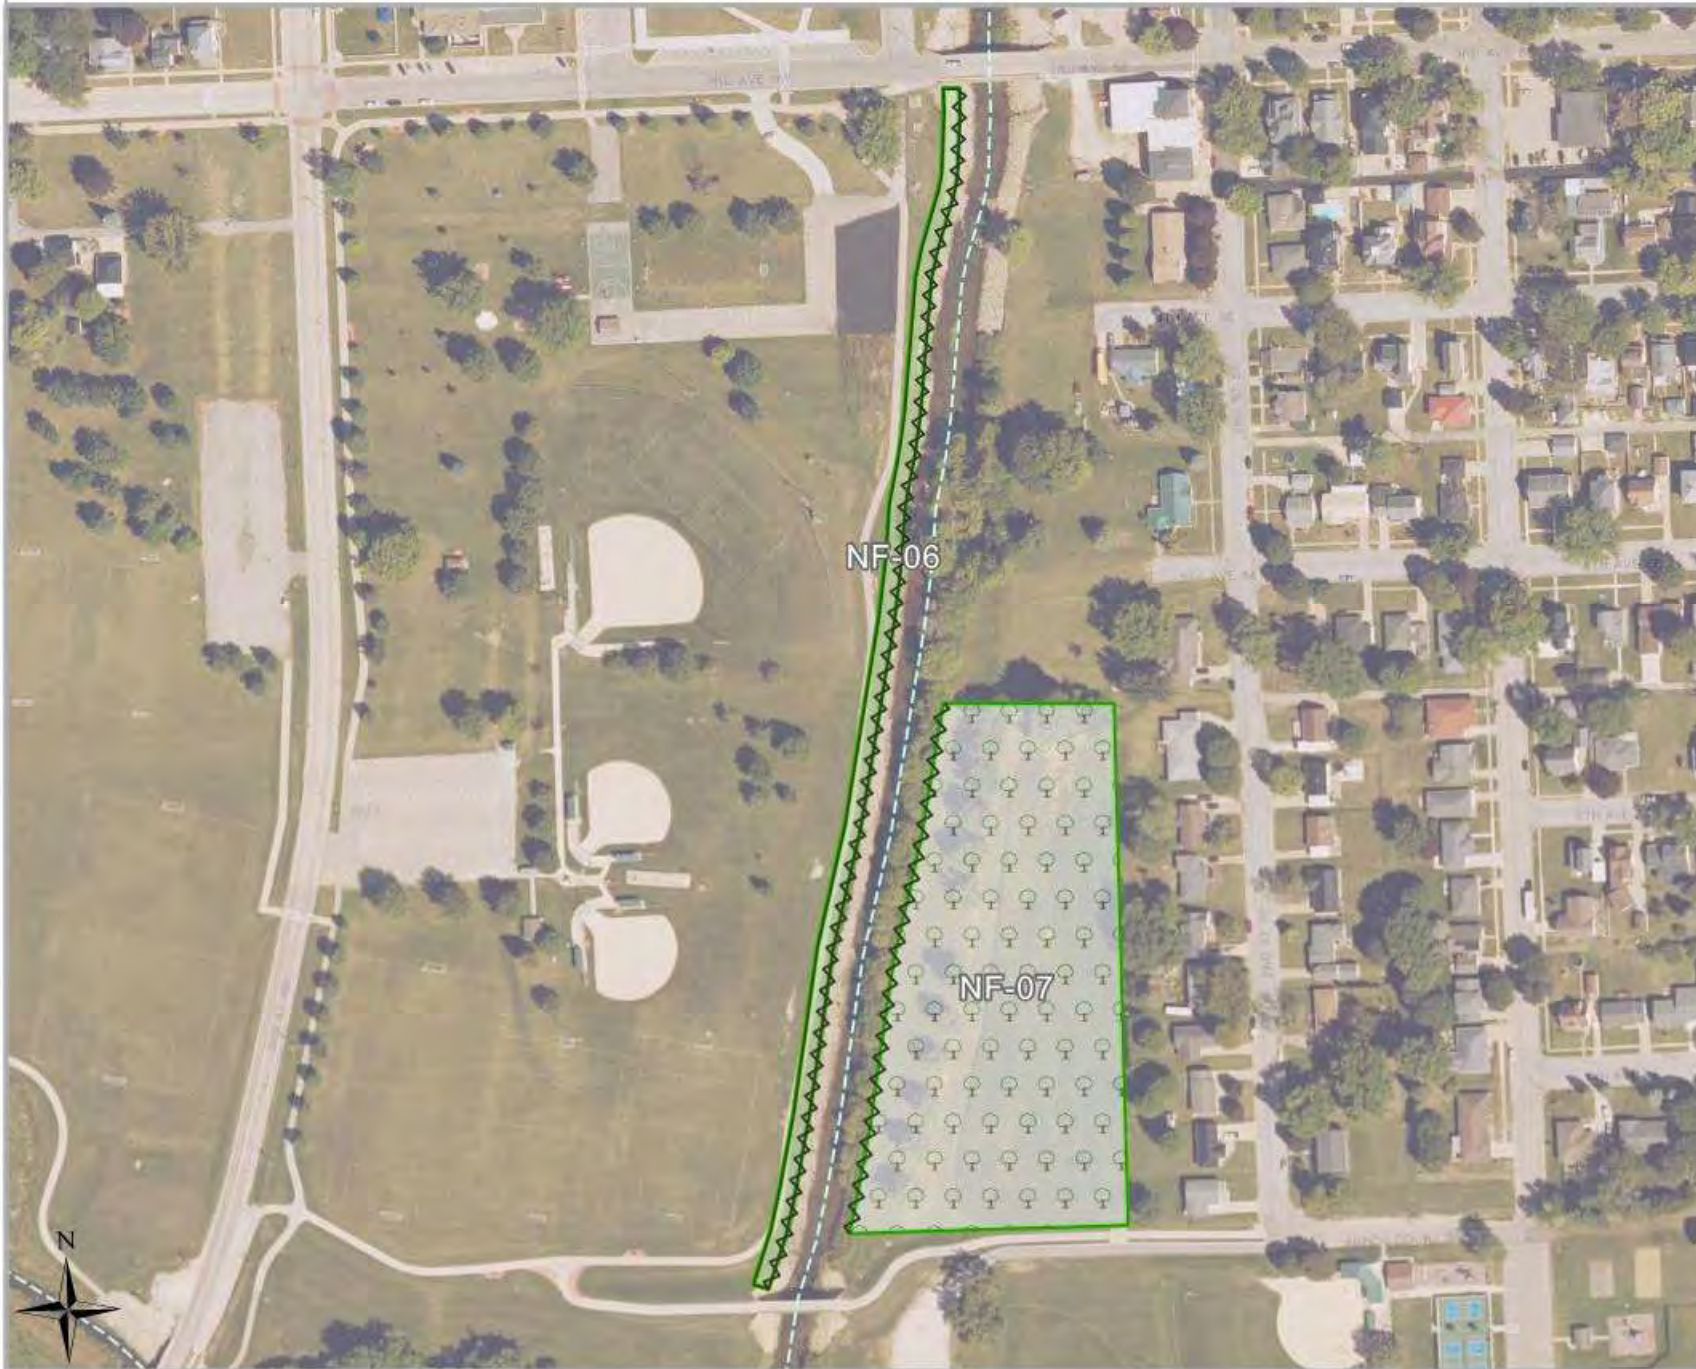
Proposed Practice NF-06 and NF-07

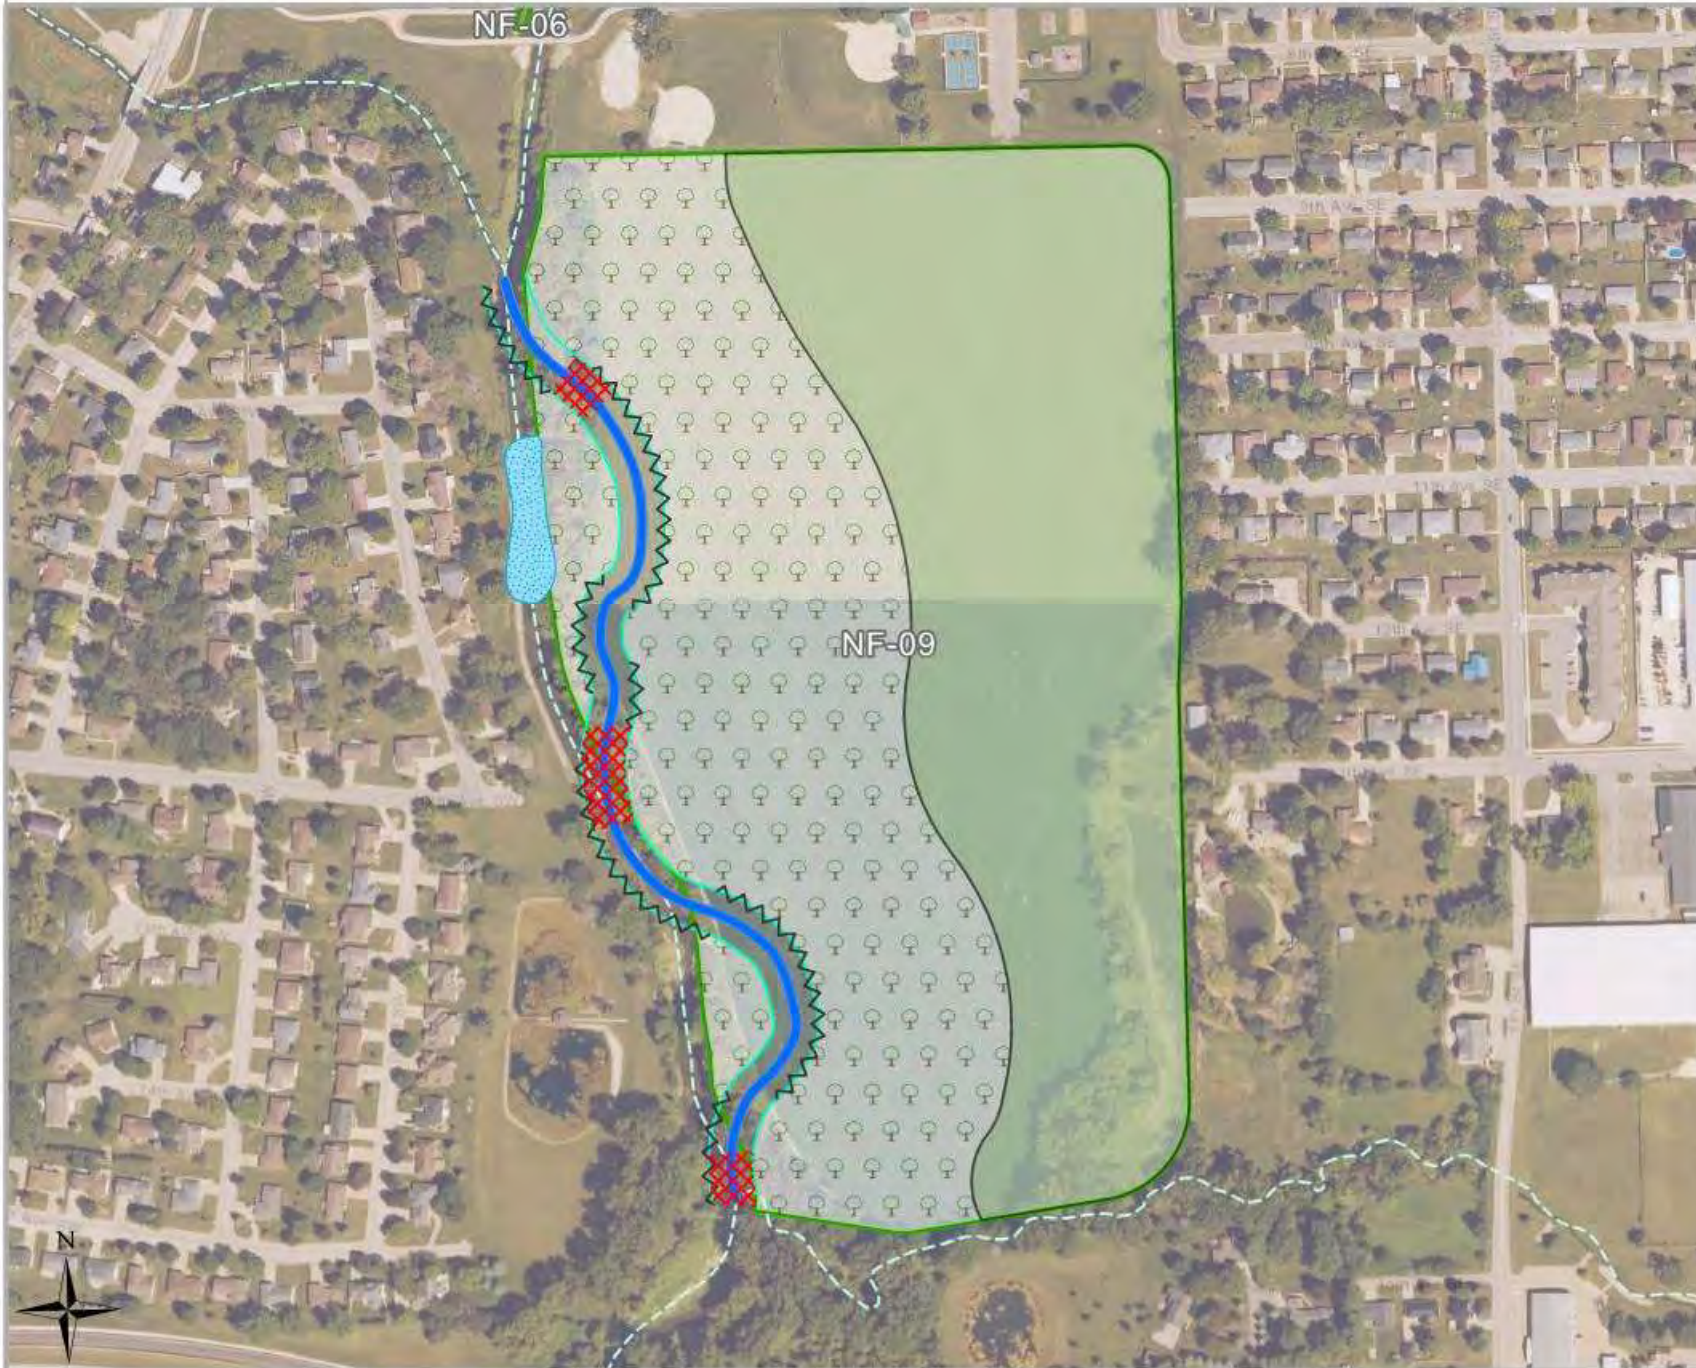
Figure 12
Proposed Practice NF-09

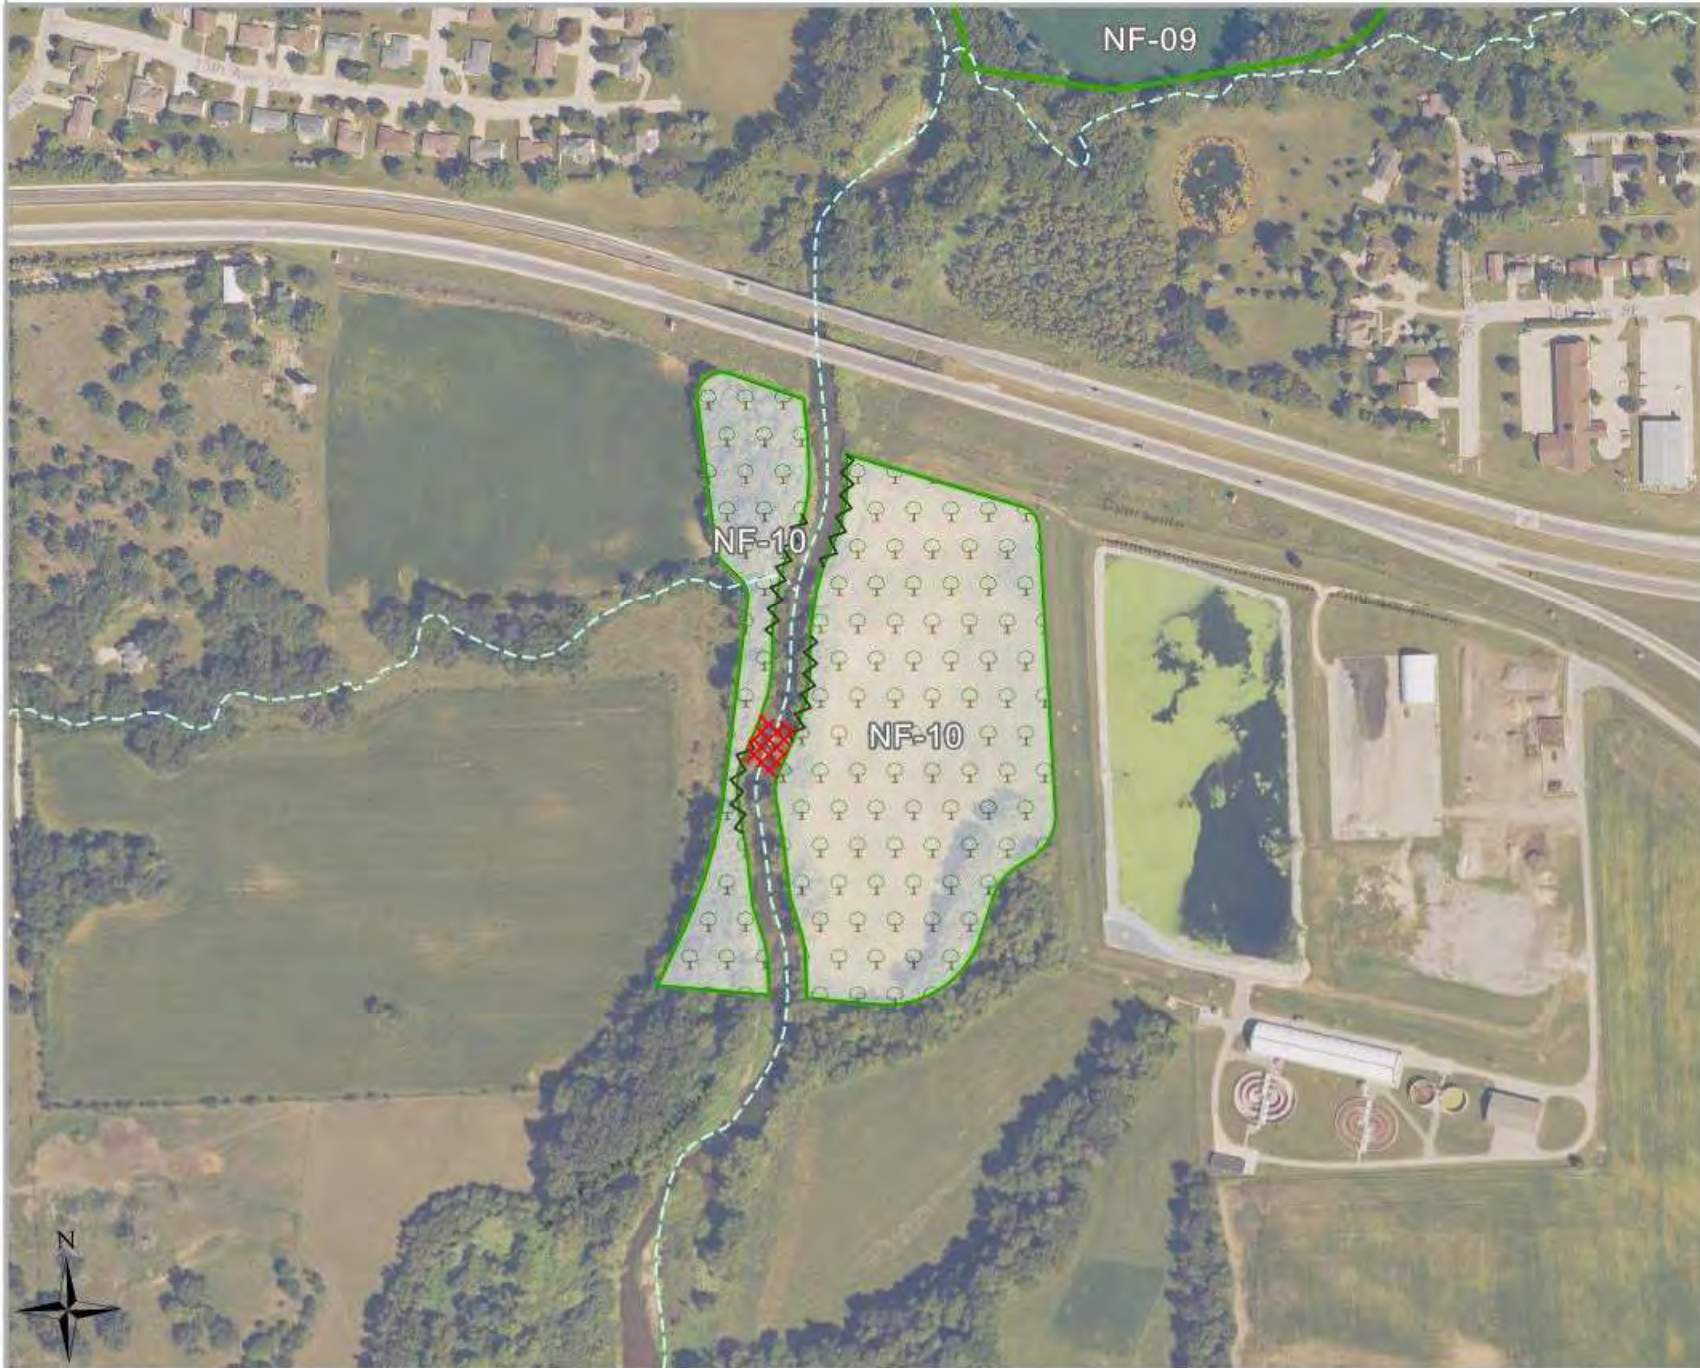
Figure 13
Proposed Practice NF-10

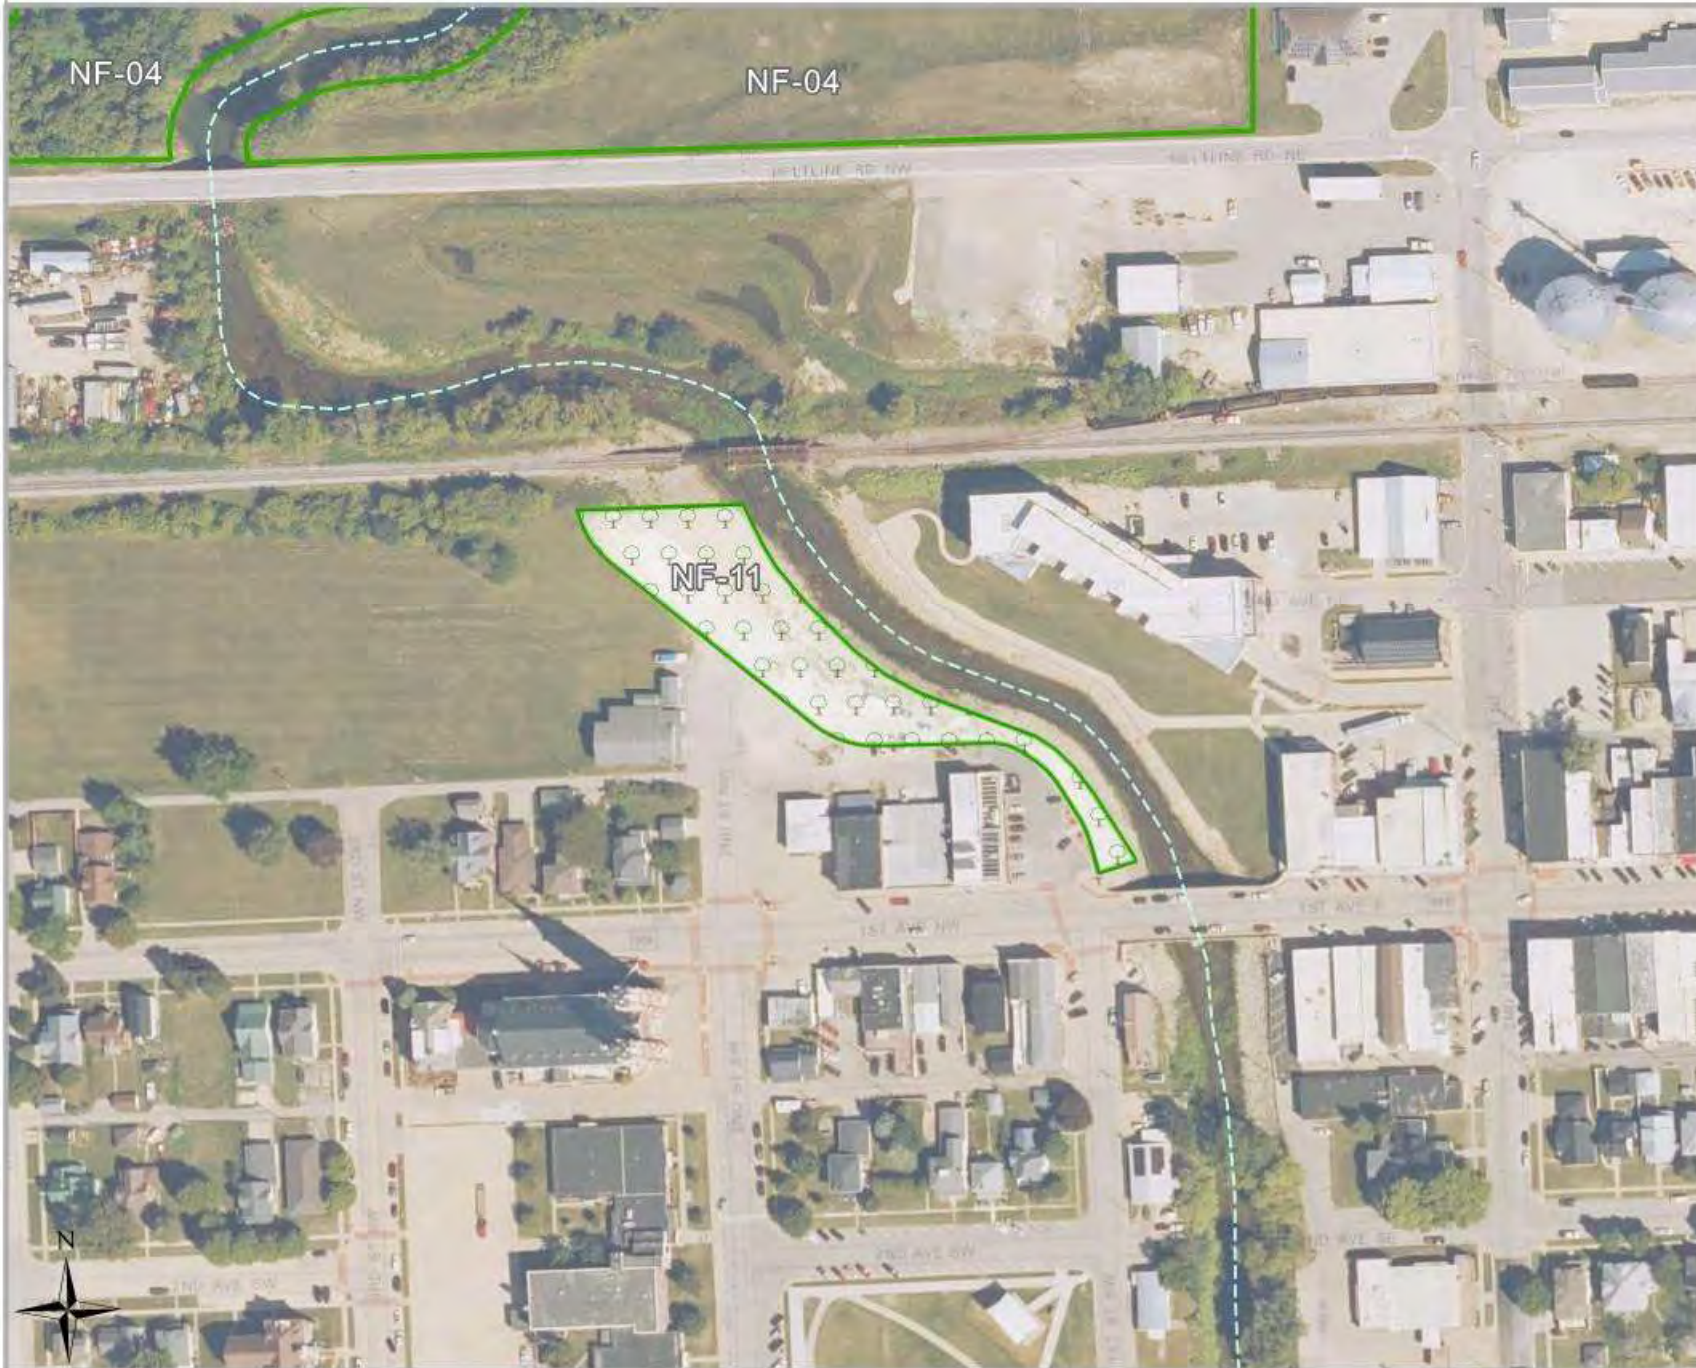
Figure 14
Proposed Practice NF-11

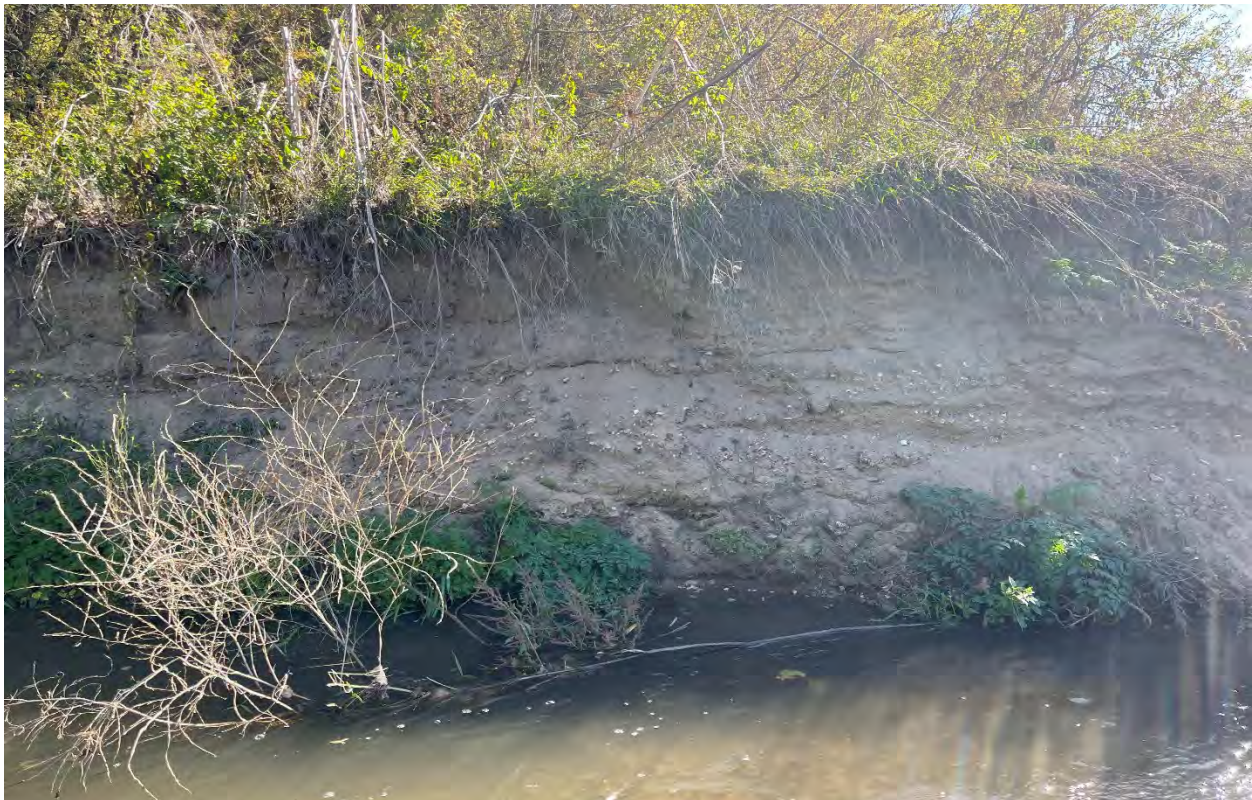
Photo point 6: North Fork Maquoketa River looking east toward severely eroded bank.
Date taken: October 10, 2023

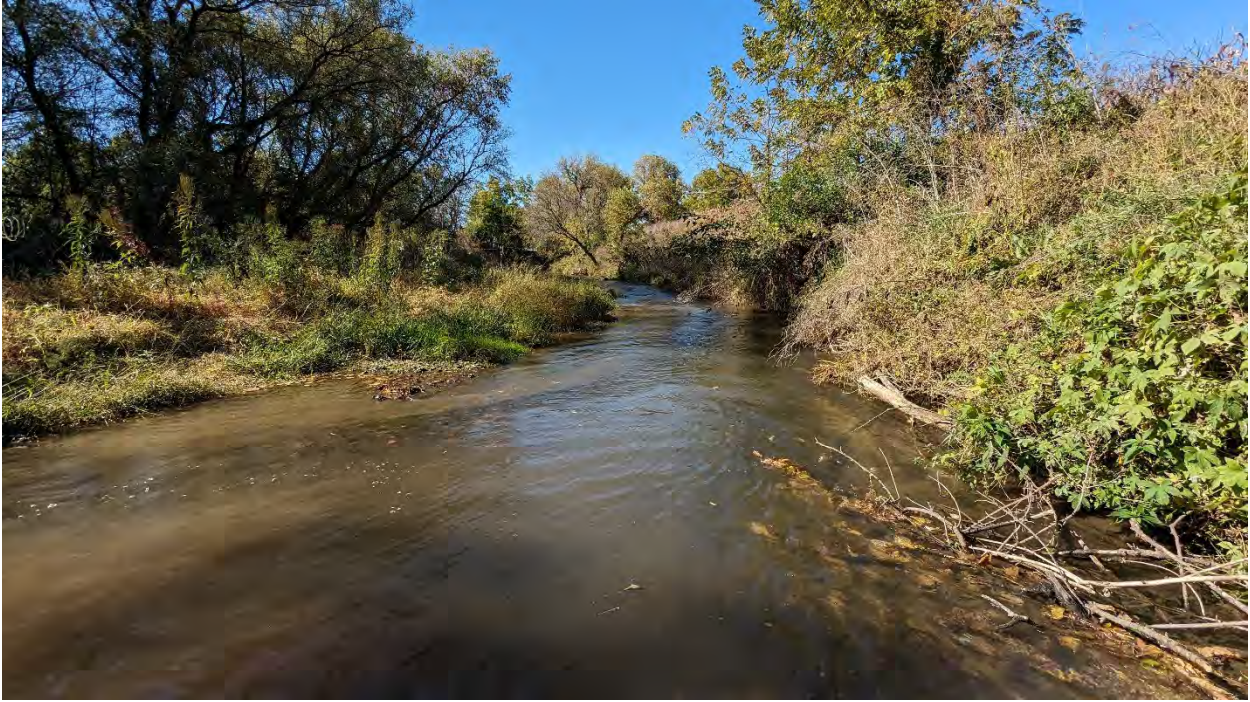
Photo point 7: North Fork Maquoketa River looking northeast. Deposition within floodplain visible on left, forming new bankfull channel. Invasive Japanese hops at right side of photo.
Date taken: October 10, 2023

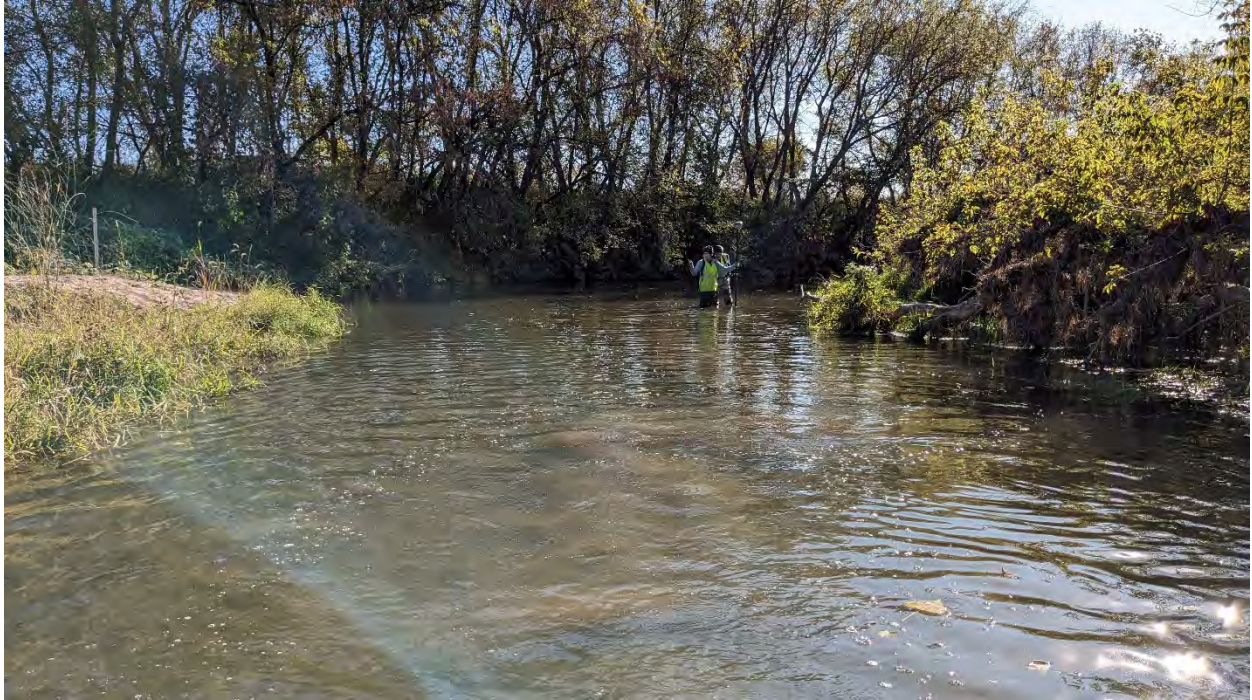
Photo point 9: North Fork Maquoketa River looking southwest. Sandbar deposition on left side of photo indicates new bankfull channel formation. Eroded banks in background.
Date taken: October 9, 2023

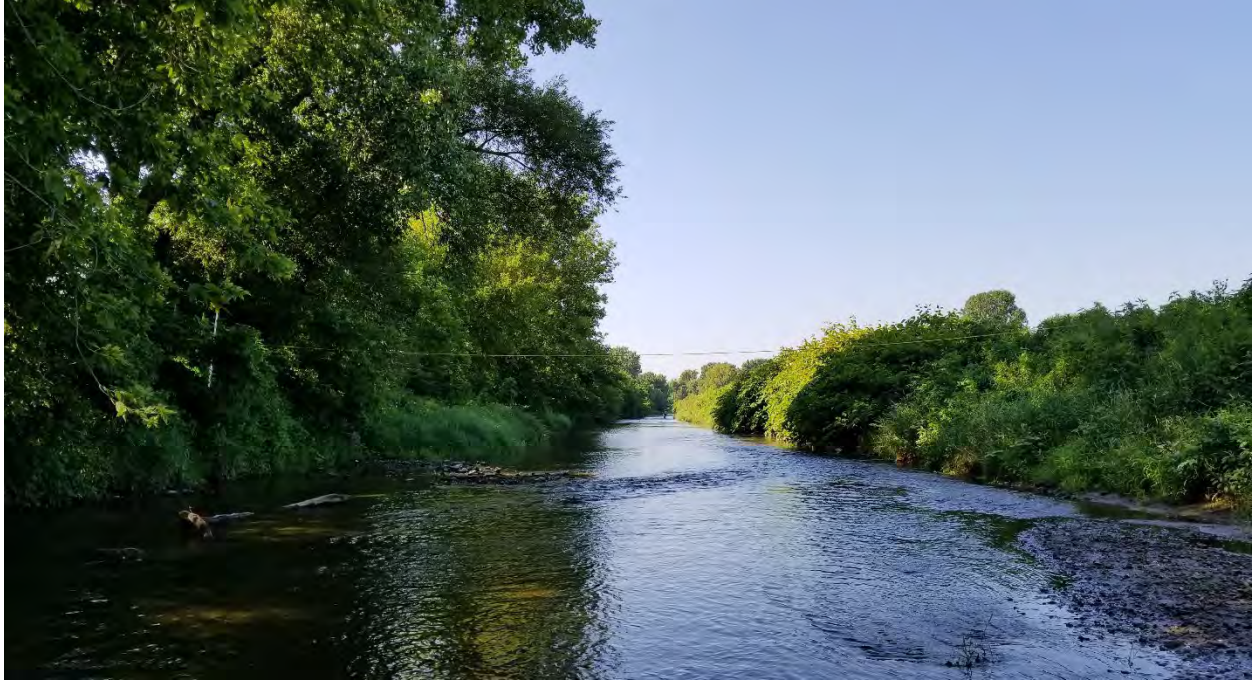
Photo point 13: North Fork Maquoketa River, looking south. Invasive Japanese knotweed lining right riverbank.

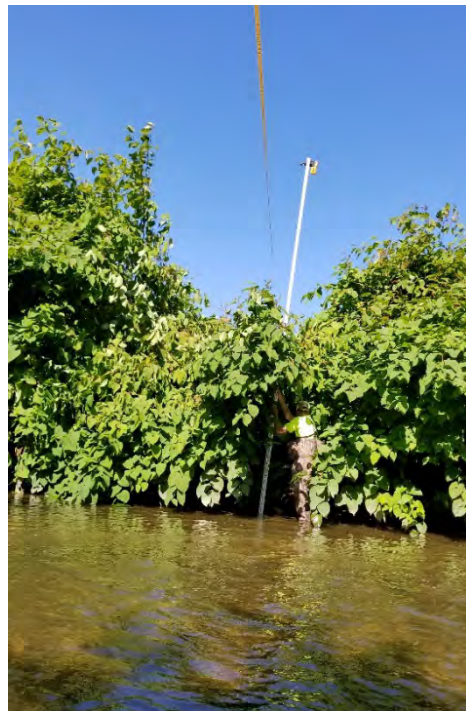
Photo point 14: North Fork Maquoketa River looking west. Invasive Japanese knotweed dominates the incised river.

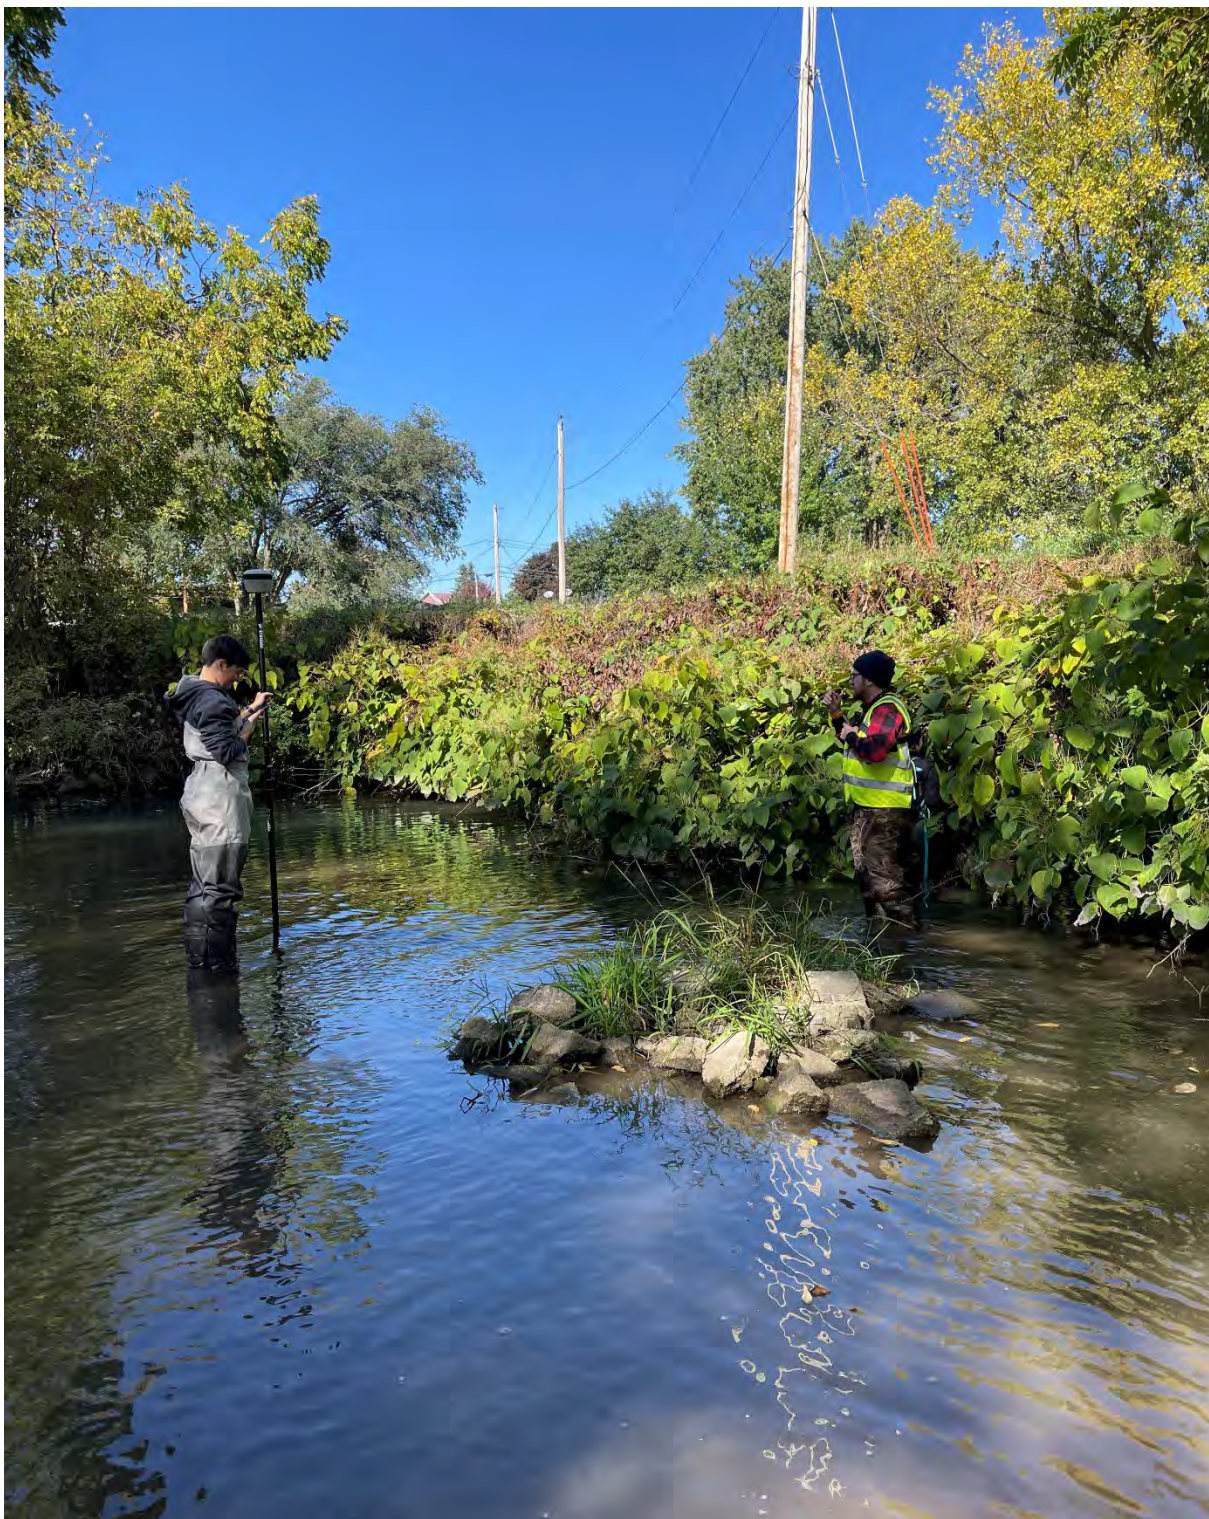
Photo point 17: Bear Creek looking west. Invasive Japanese knotweed covering and otherwise unstable streambank.
