Appendix A:
Building Resilient Infrastructure in Communities
(BRIC) Scoping Study

FEMA Building Resilient Infrastructure and Communities (BRIC) Scoping Study for the City of Dyersville

City of Dyersville, Iowa

November 22, 2024

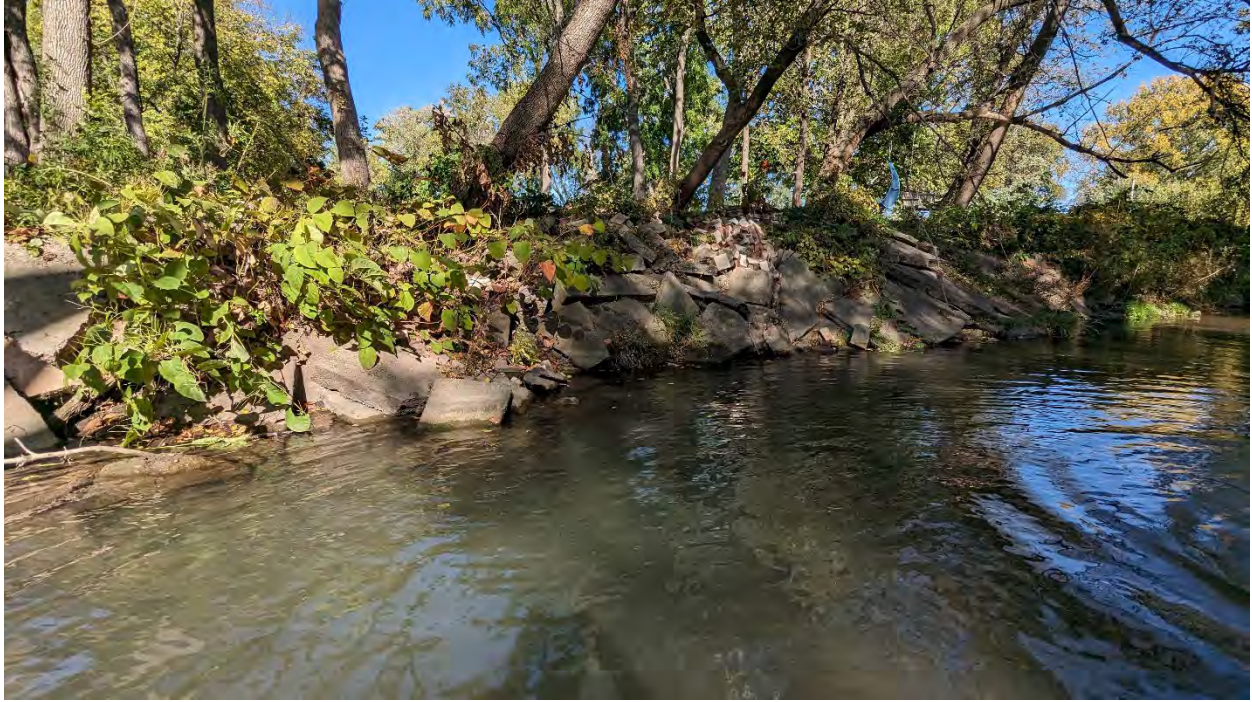
Photo point 18: Bear Creek looking south. Old pieces of concrete sidewalk used for bank stabilization.
Date taken: October 10, 2023

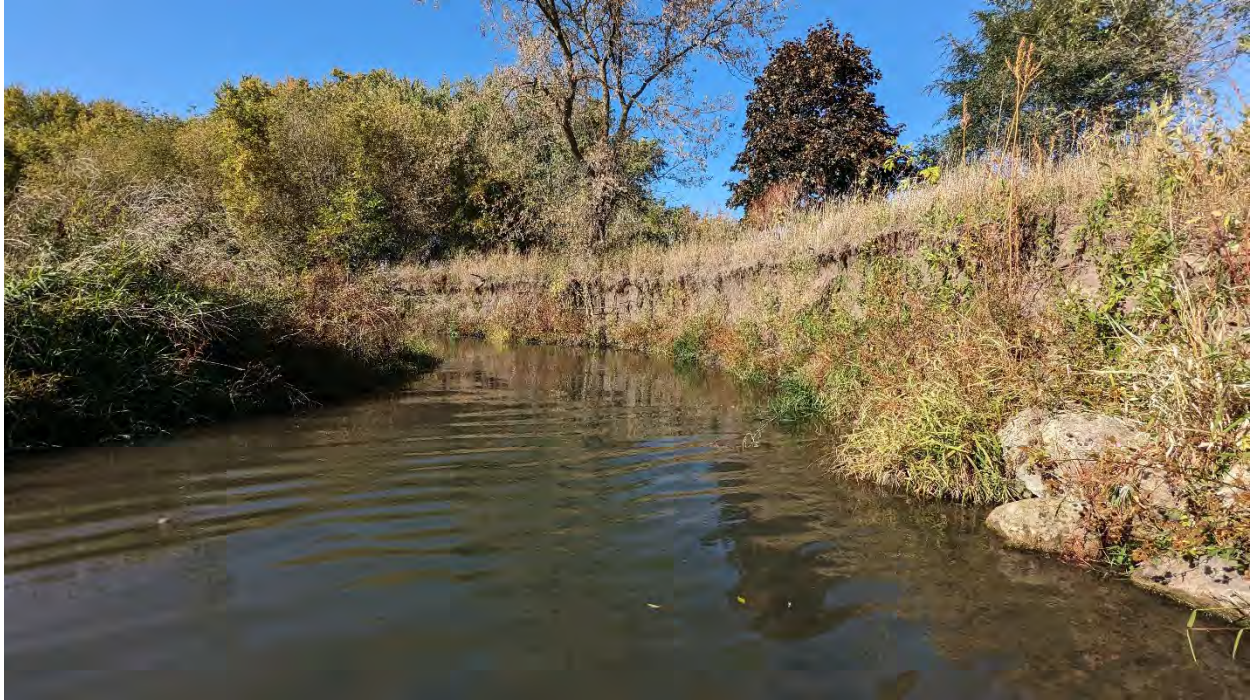
Photo point 20: Bear Creek looking southeast. Severely eroded, overhanging bank.
Date taken: October 10, 2023

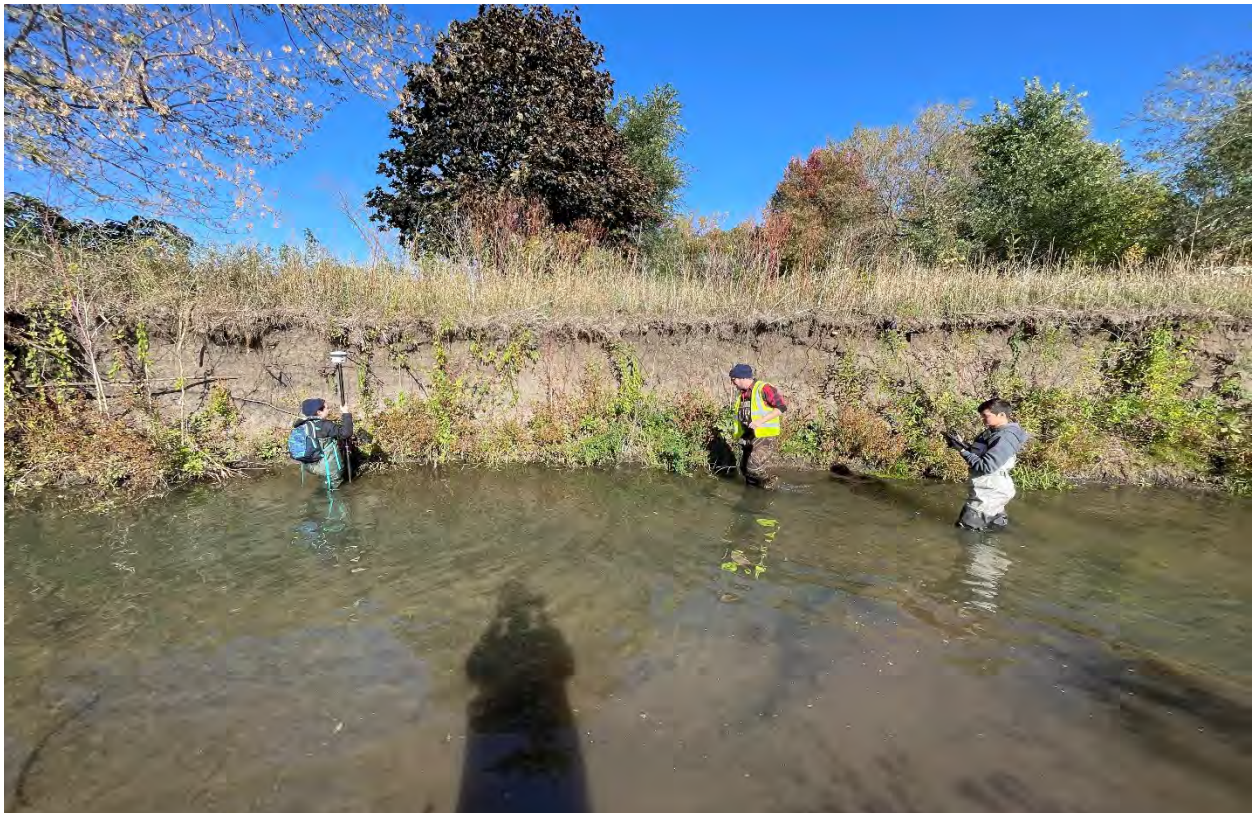
Photo point 21: Bear Creek looking southwest. Severely eroded bank shows degree of stream incision.
Date taken: October 10, 2023

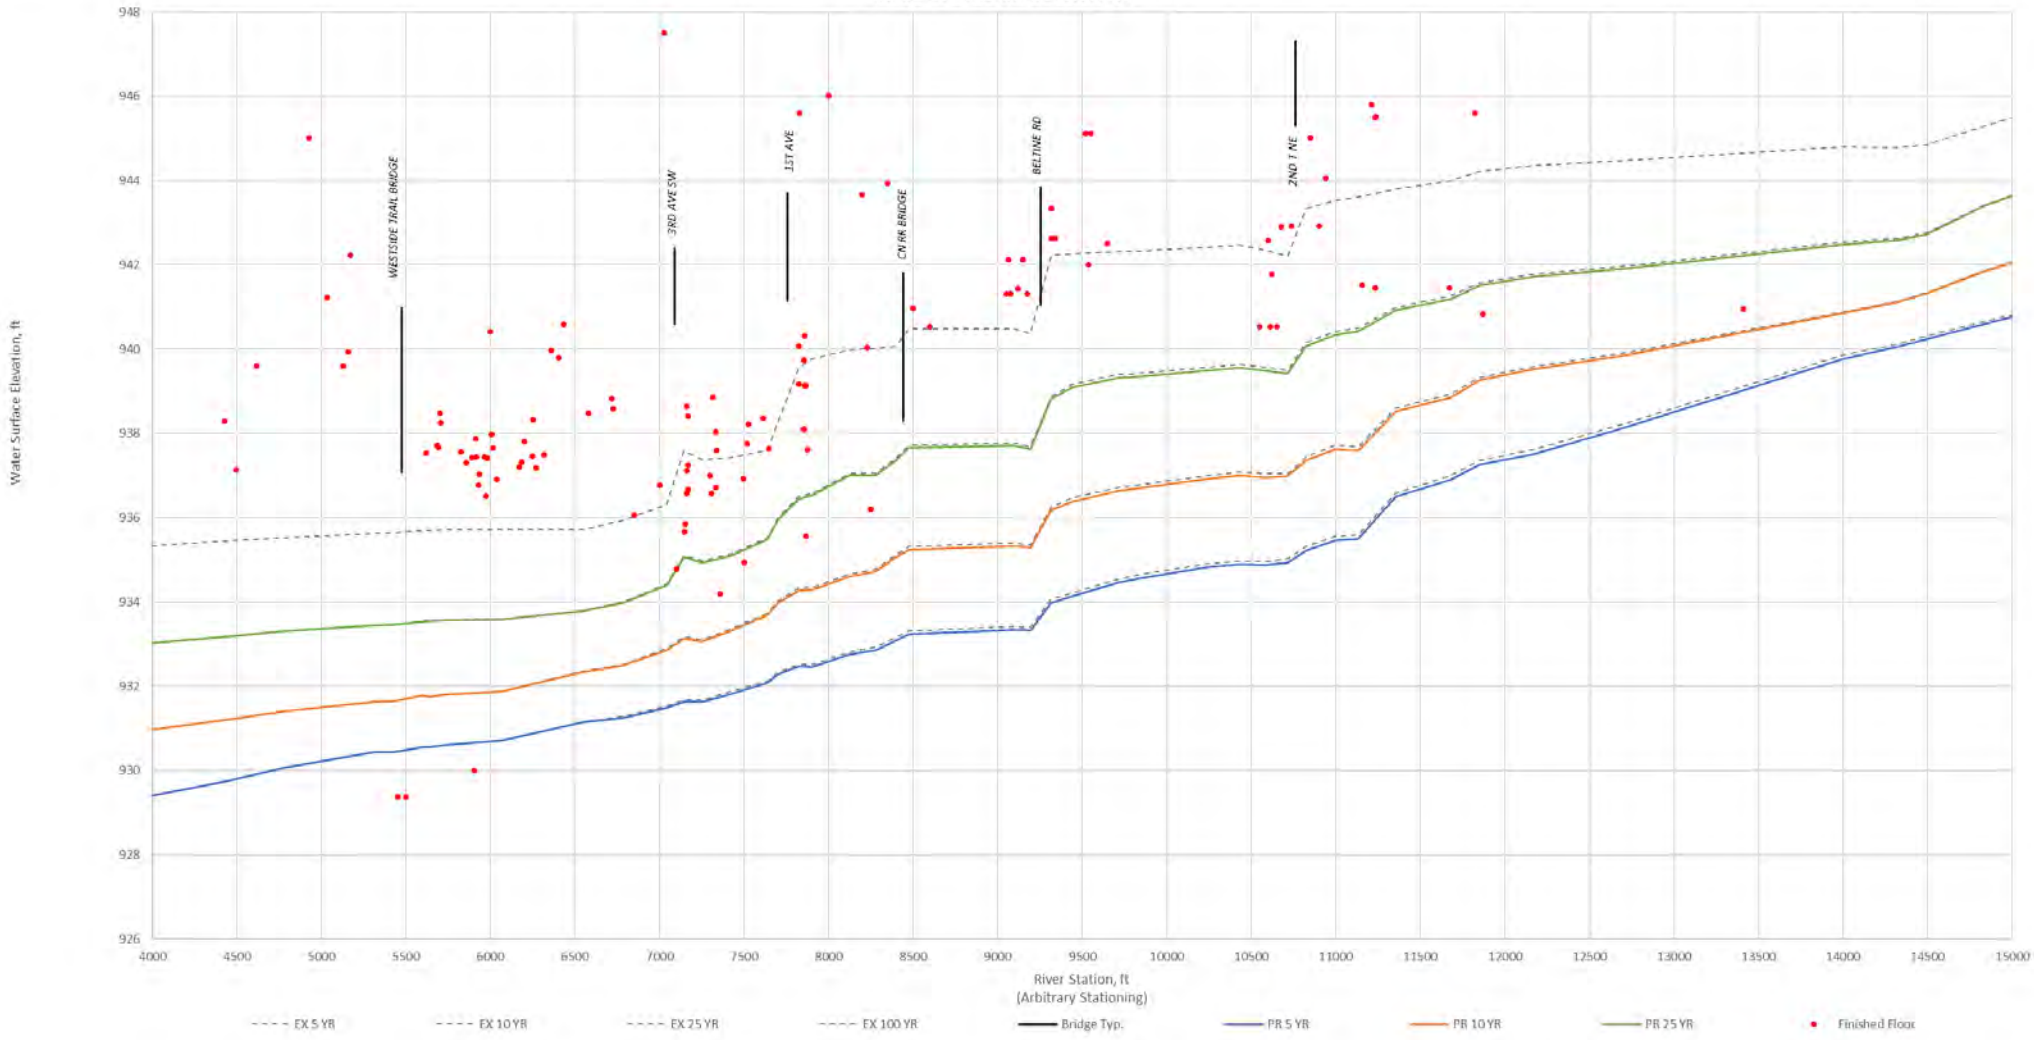
NF01 UPSTREAM DETENTION

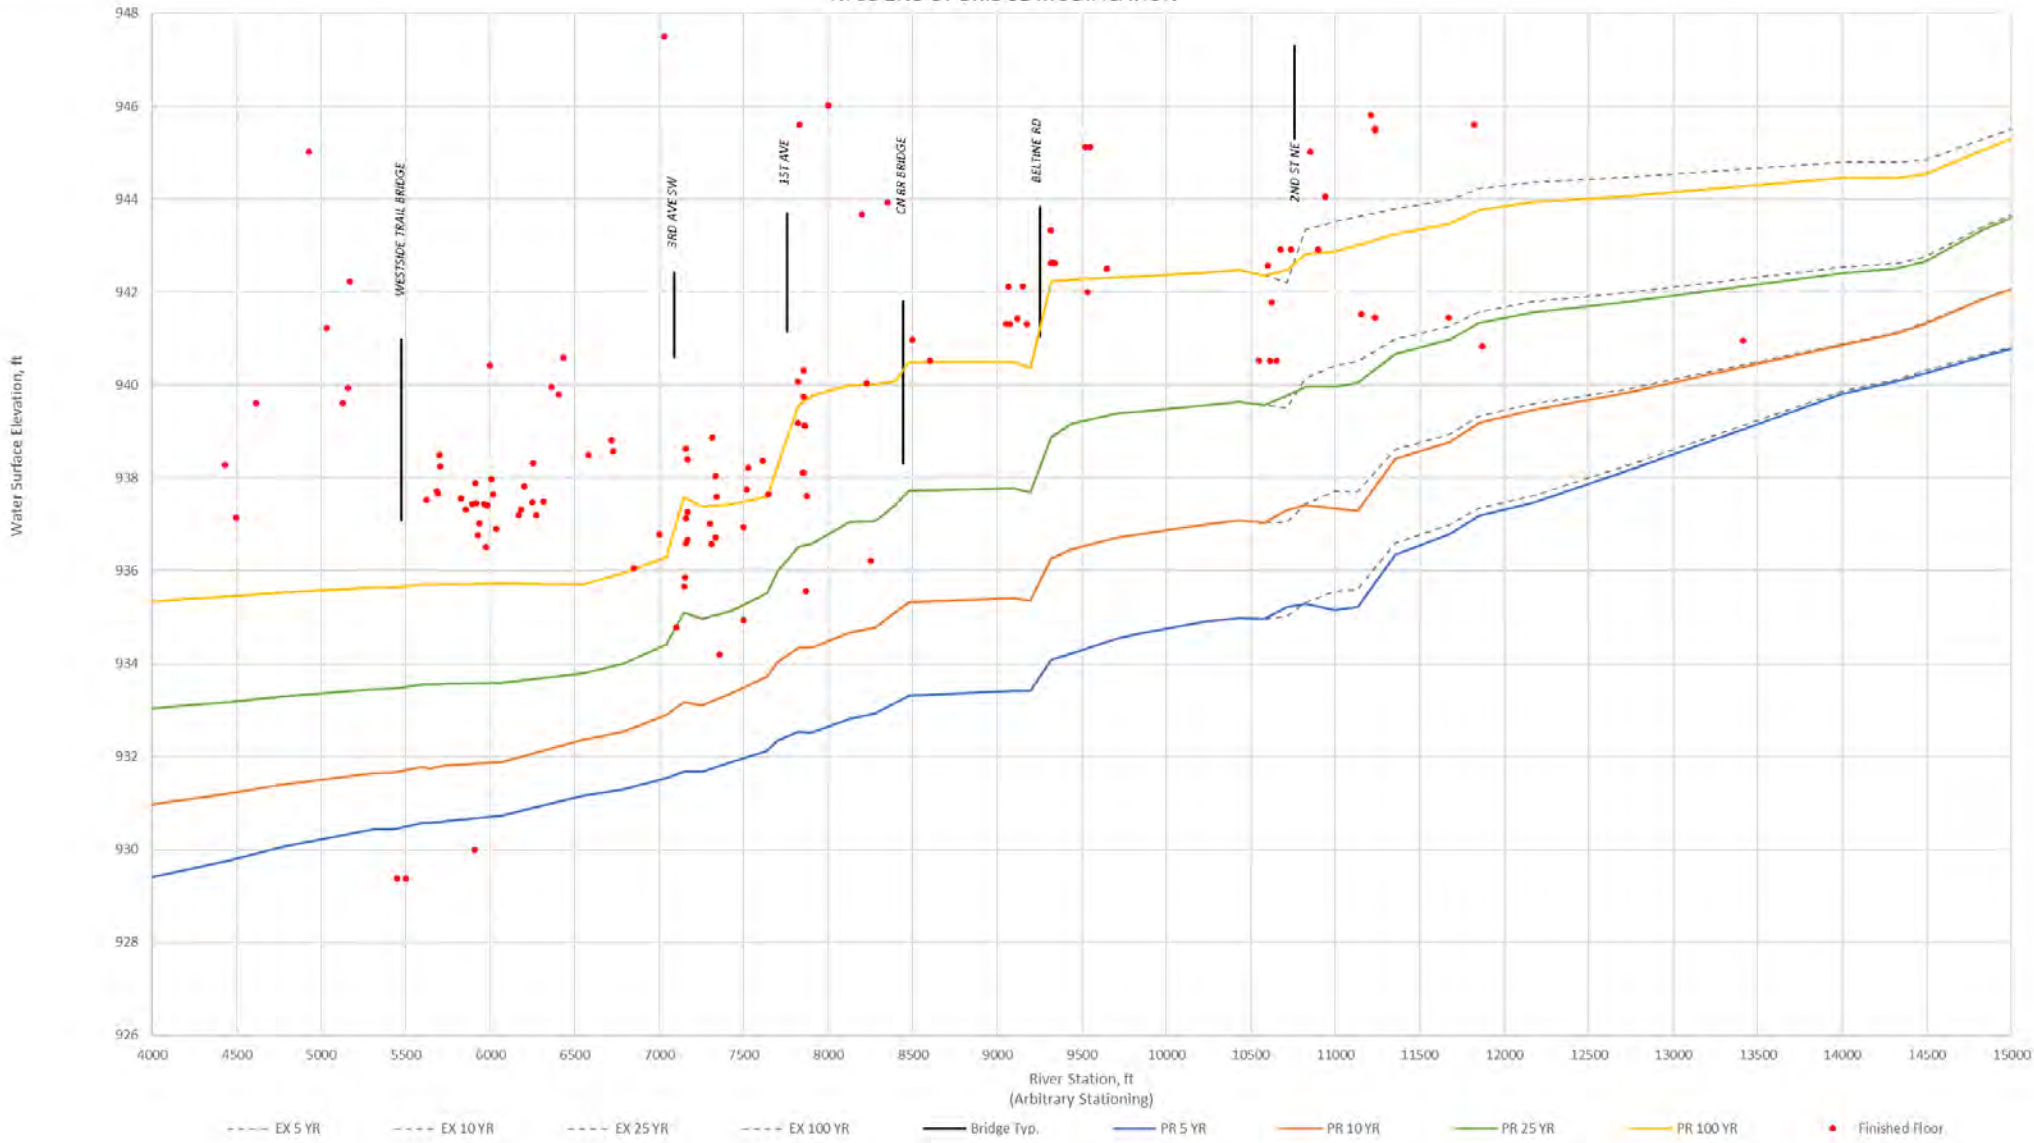
NF03 2ND ST BRIDGE MODIFICATION

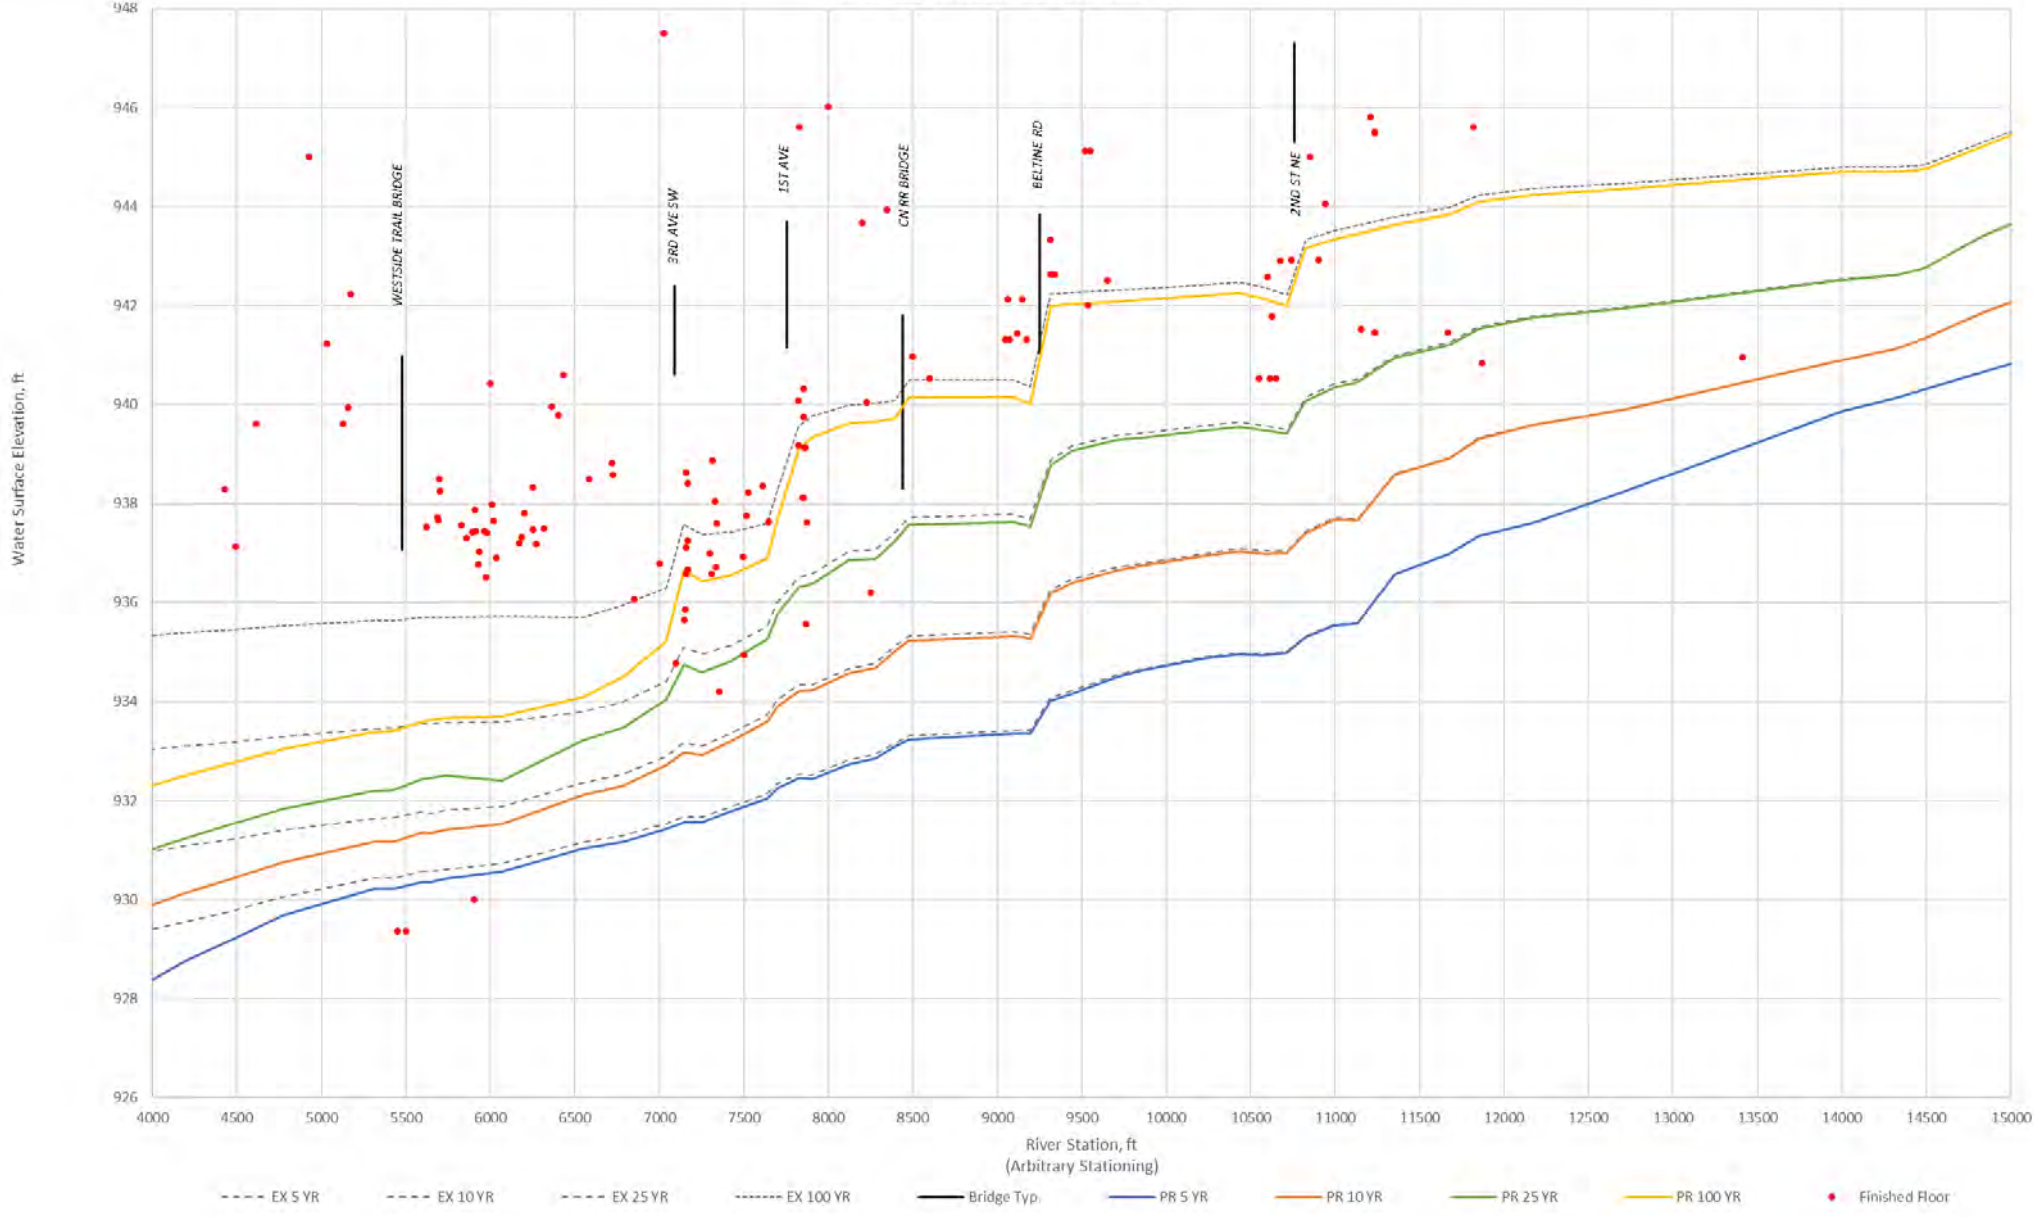
NF10 EXCAVATION SOUTH HWY 20

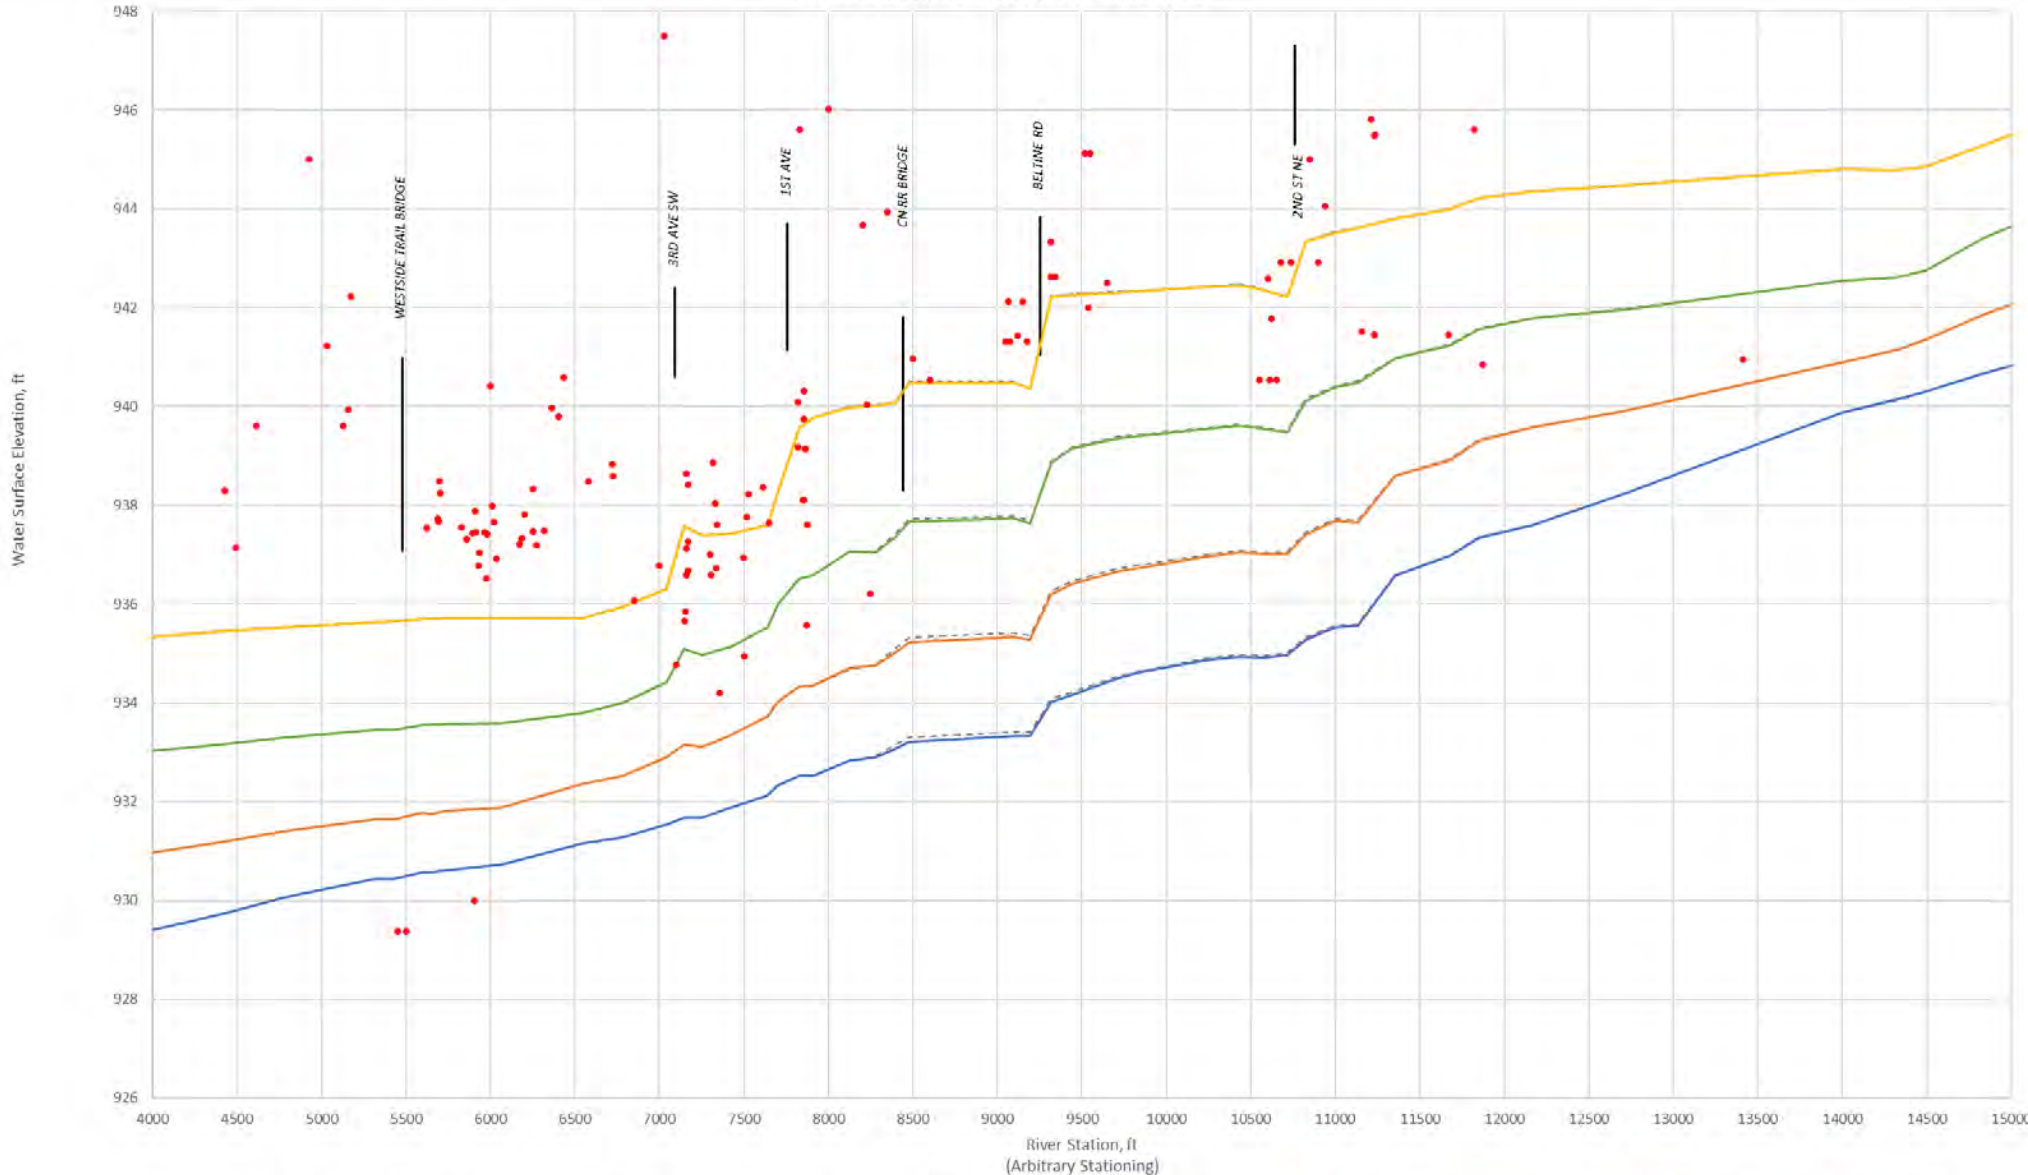
NF11 EXCAVATION SOUTH OF RAILROAD
